## 5. VILLAGE OF COLD SPRING - ROUTE 9D FROM MAIN STREET TO CHESTNUT STREET

Putnam County Main Street Partnership Planning Study  
Figure 5.1 Cold Spring Pedestrian Improvements

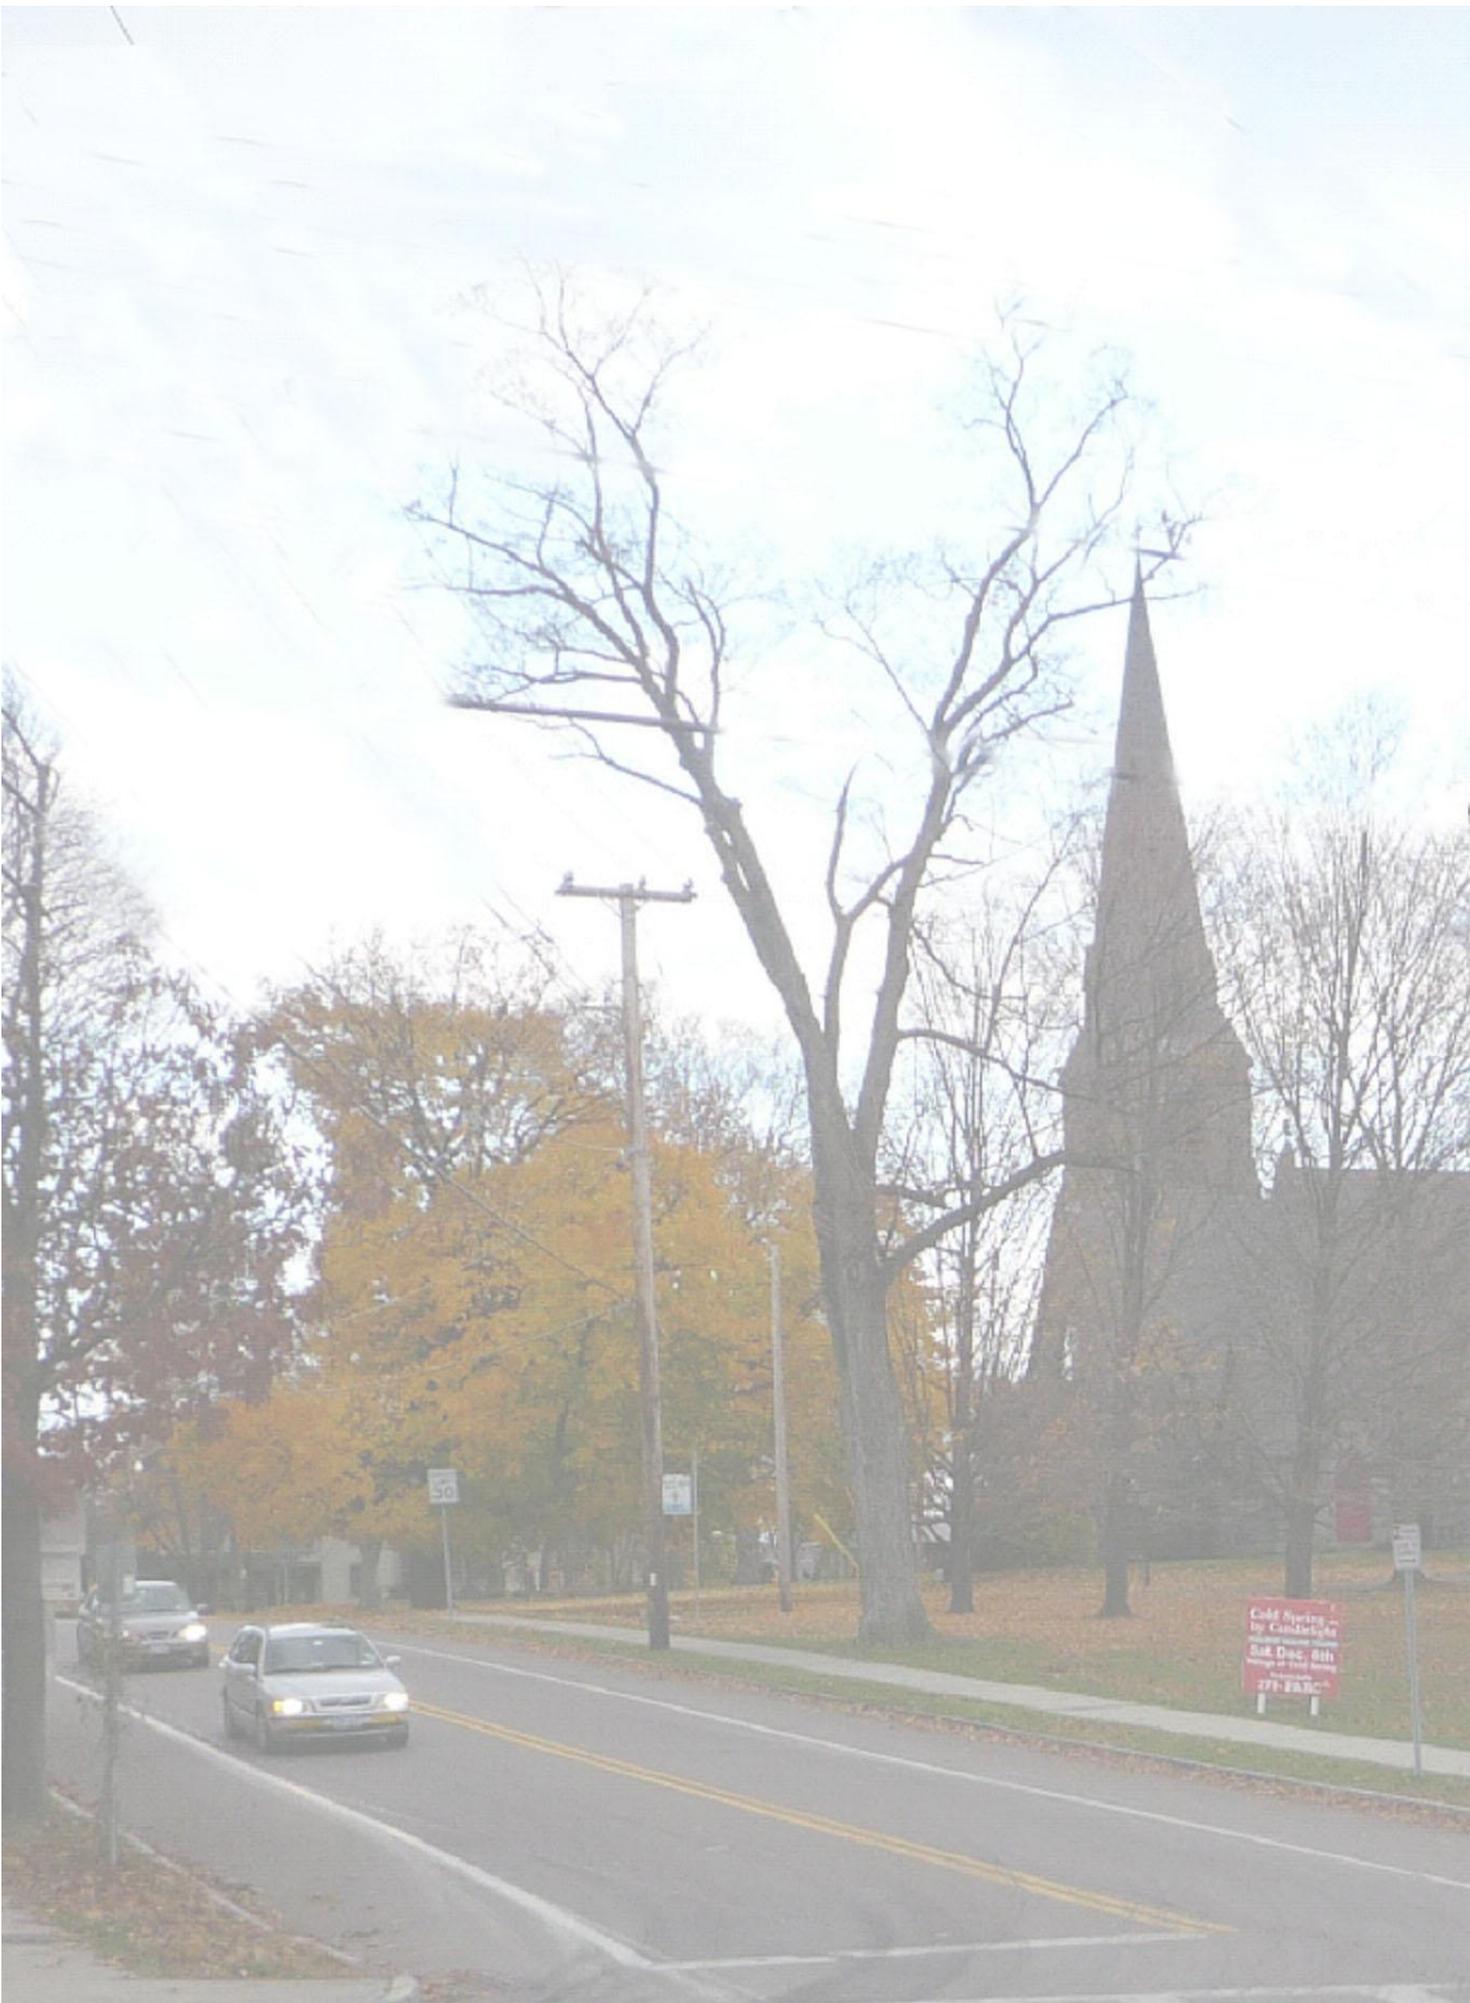
The recommendations below can be referenced by referring to Figure 5.1.

To address pedestrian safety conditions for crossing Route 9D, a few simple measures could be adopted which together will strengthen the concept of a “pedestrian safety zone” at this location. While attempts have been made to create crossings at convenient locations, there are far more desire lines for crossing than have been provided. It is recommended to install several new crossings along this section of Route 9D. These new uncontrolled crosswalks should be striped and signed per the Manual of Uniform Traffic Control Devices (MUTCD) requirements, but it is also recommended that they be paved with a decorative “brick-like” material called BrickPrint®.

BrickPrint is a highly durable thermoplastic-based material, which can be inlaid to create a surface that is flush with the asphalt. It is designed to resist fading and the color is aggregate in the material, so it does not fade like other decorative crosswalk treatments. The life span of BrickPrint is intended to match that of asphalt, so it will not wear before a repaving is necessary.

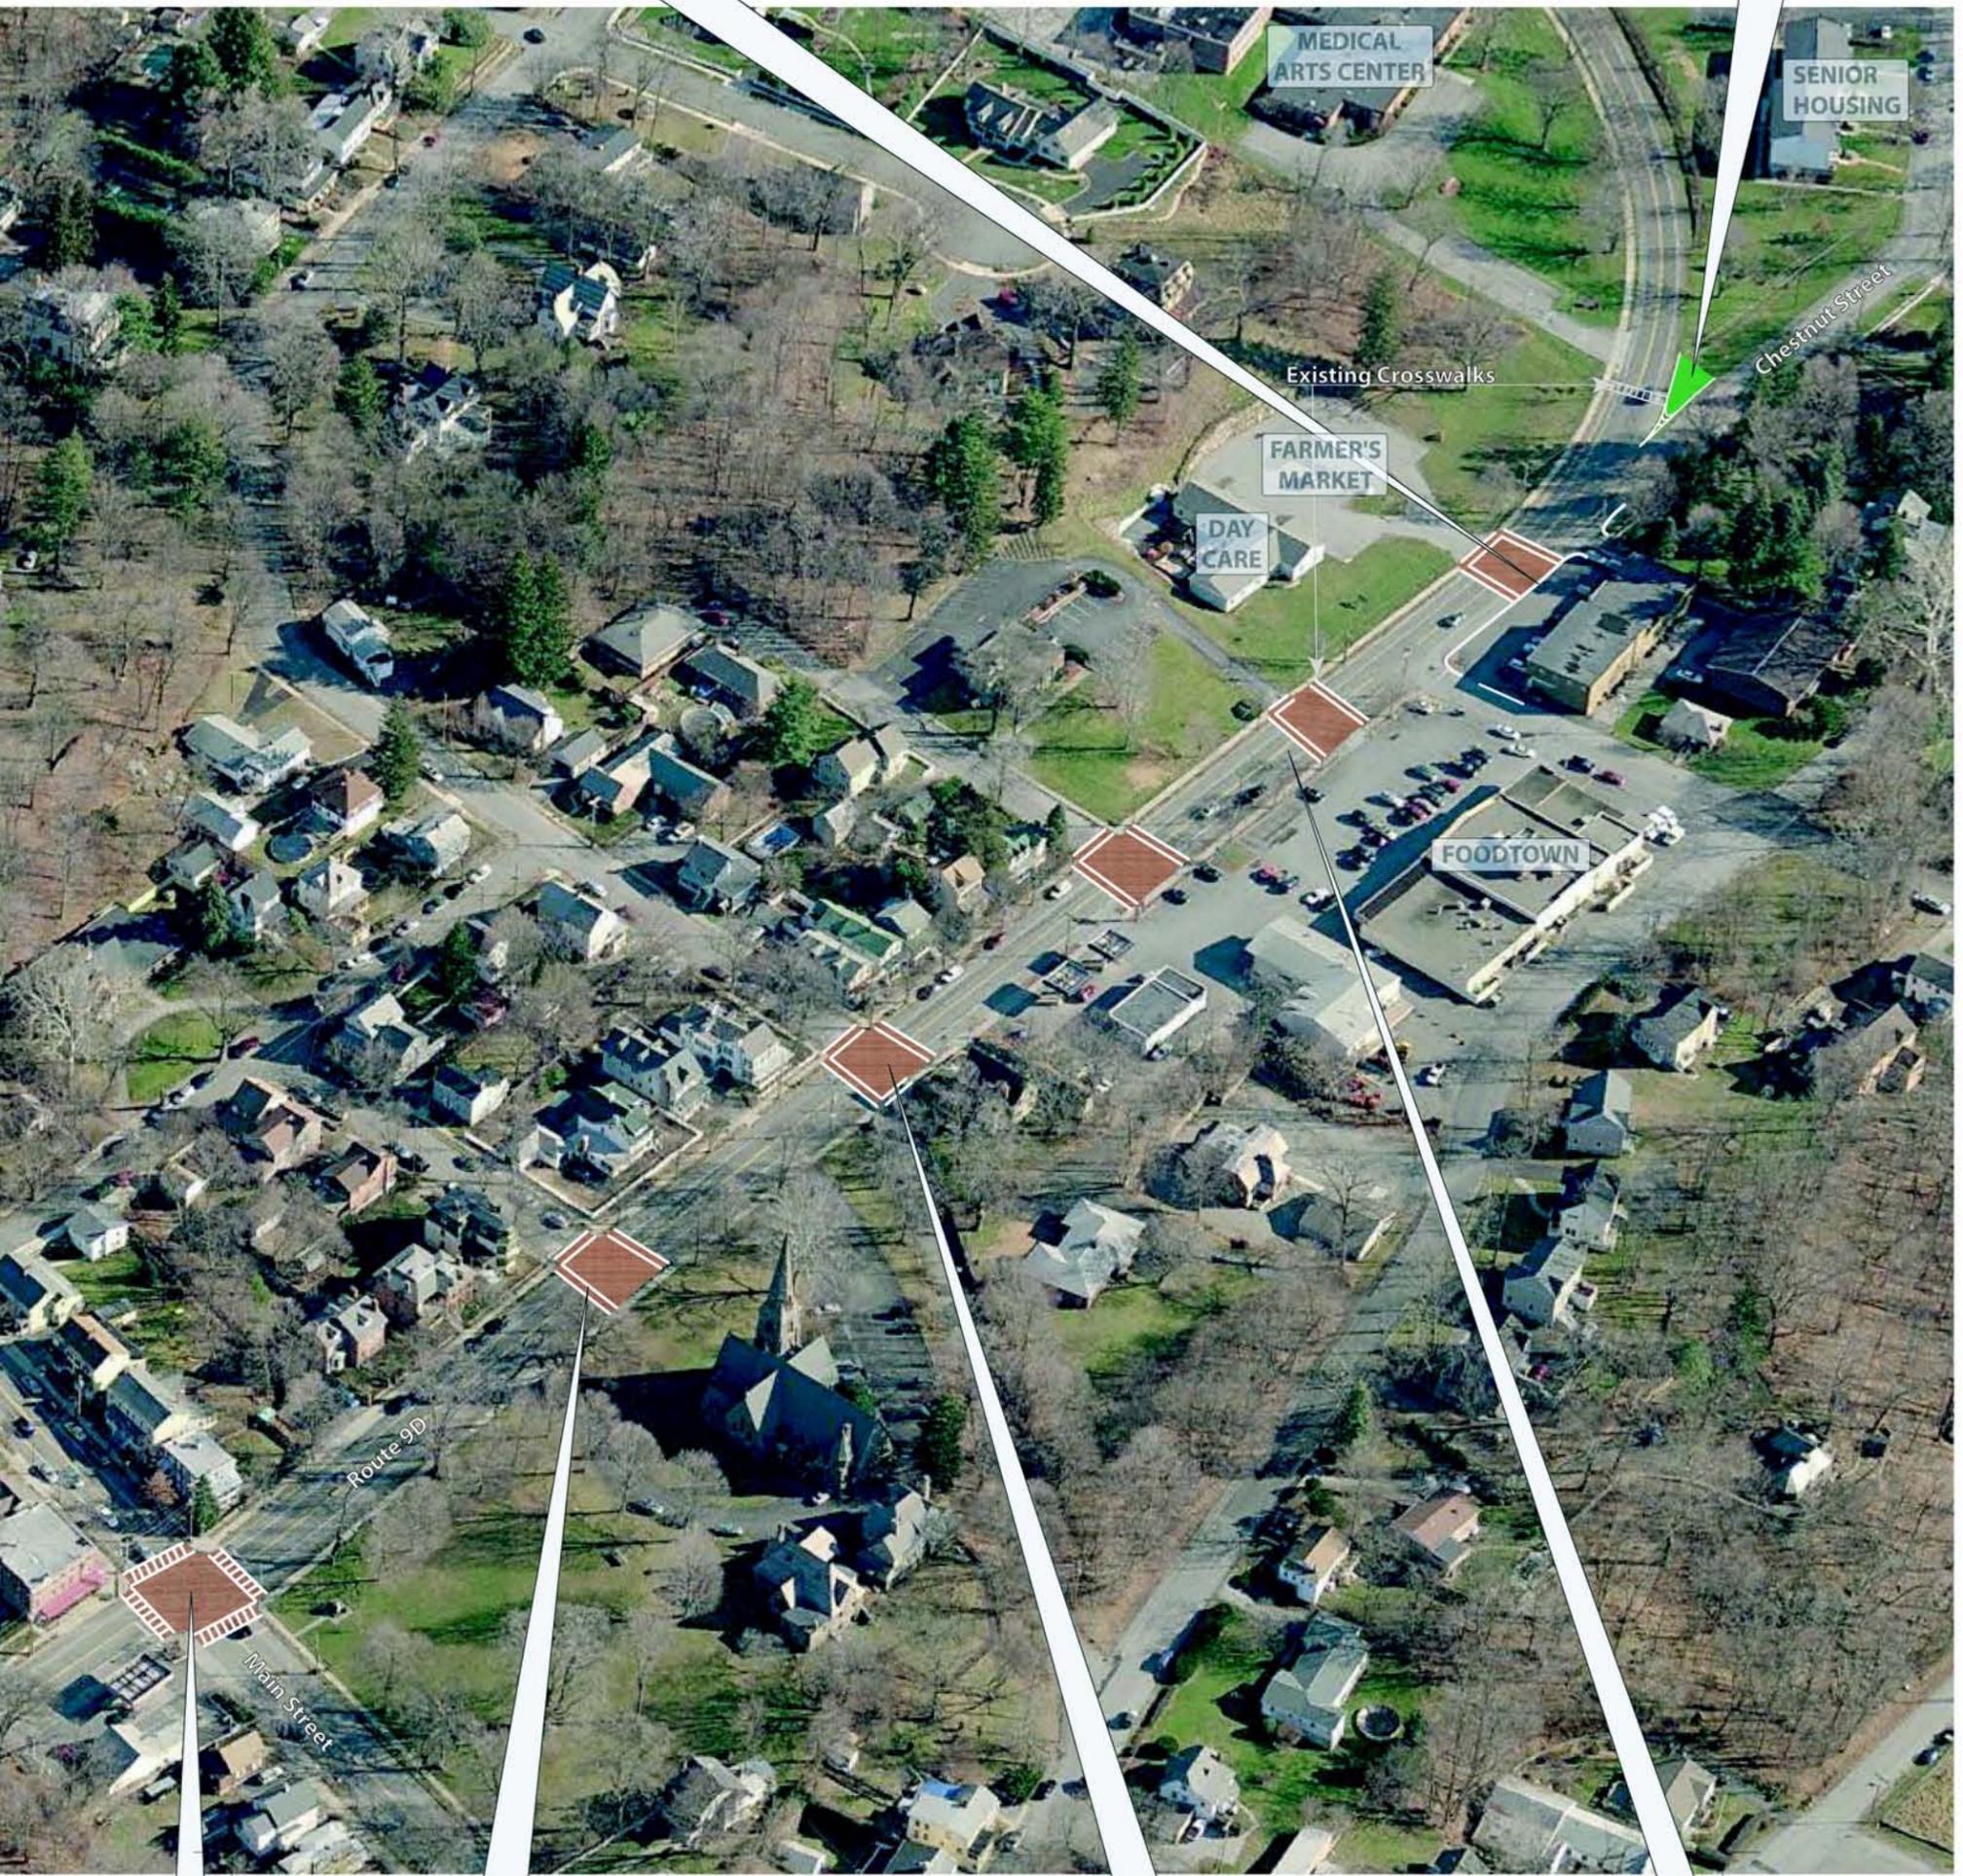
Continuous sidewalks are an essential pedestrian amenity. In addition, providing openings for vehicles to enter and exit the parking lot is important for access management.

In order to make the existing crossing more safe, the area between these two roads should be extended to provide a refuge area for pedestrians as they cross.

Retro-reflective thermoplastic crosswalks highlight specific crossing locations for drivers and pedestrians. Pedestrian actuated flashing crosswalks could also be considered.

Distinctive pavement at crosswalks and intersections serve as a visual and textural indicator to drivers that pedestrians will be present. To produce this effect, stamped concrete, brick pavers or another material may be used in order to maintain the historic character of the Village.
